NASA CR-145033

A STUDY TO IMPROVE THE MECHANICAL PROPERTIES OF SILICON CARBIDE RIBBON FIBERS

Prepared under Contract NAS 1-13018

Avco Systems Division
Lowell Industrial Park
Lowell, Massachusetts 01851

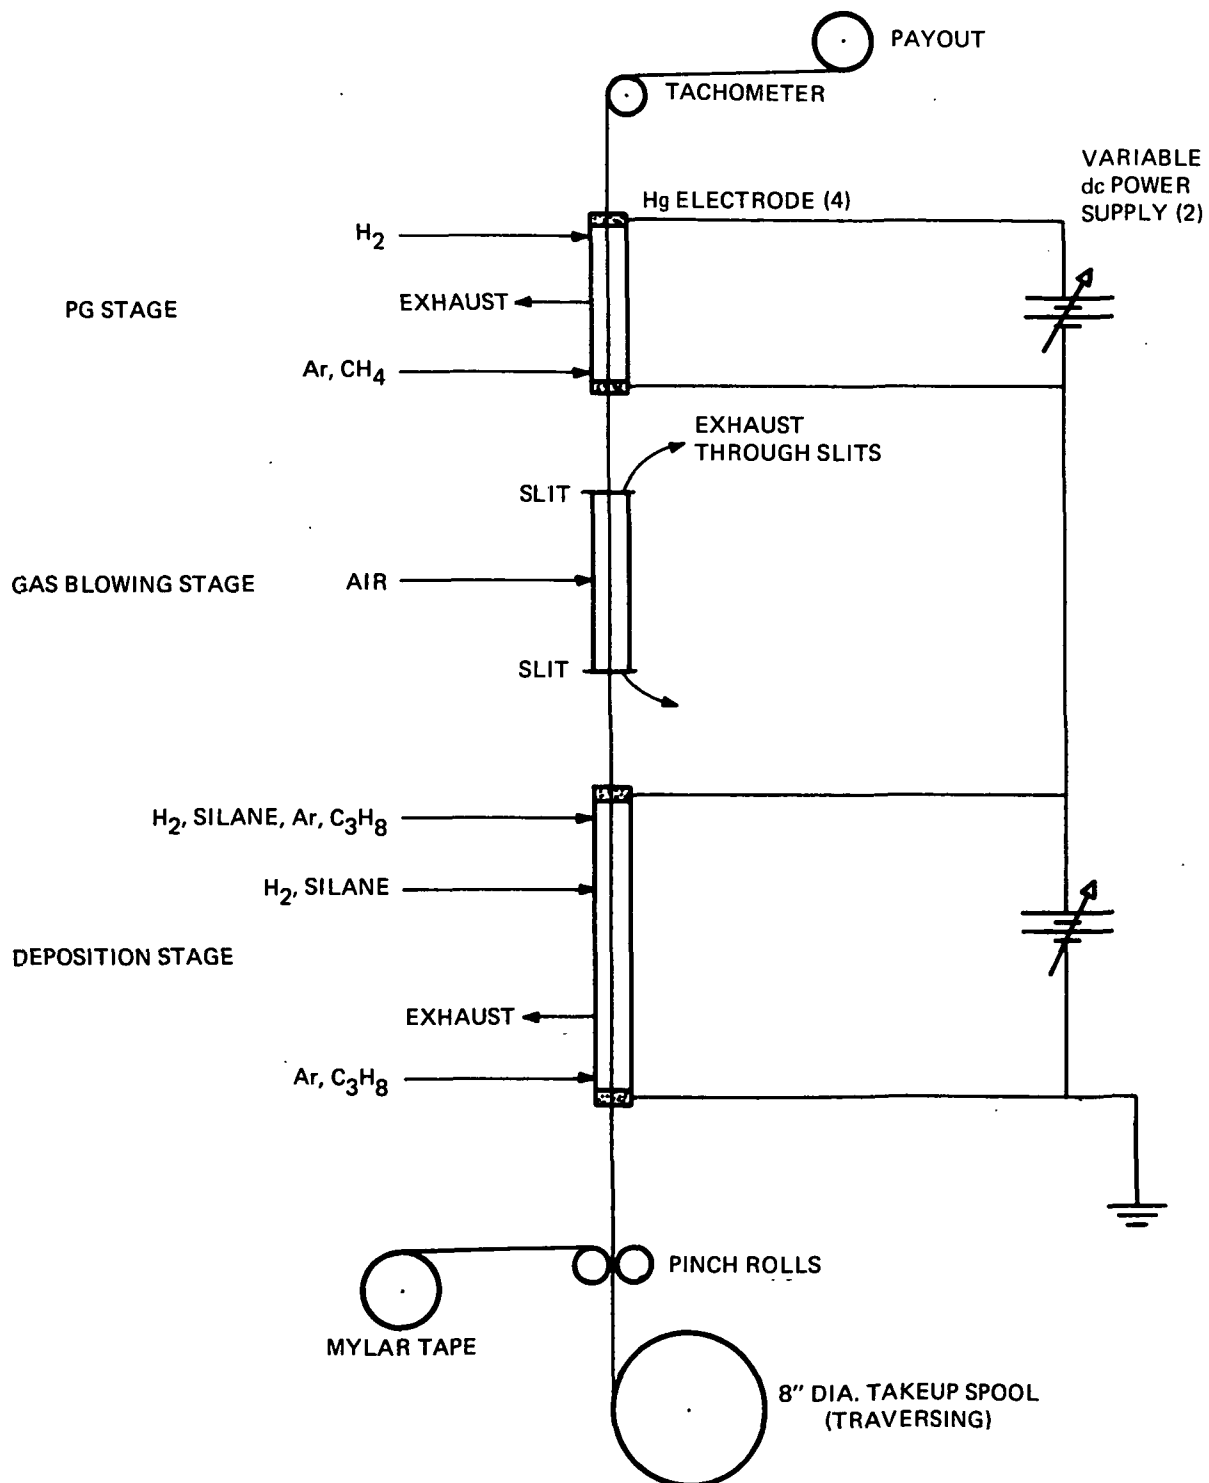
86-1524

Figure 1 SCHEMATIC DIAGRAM OF SiC RIBBON DEPOSITION REACTOR

The first series of SiC ribbon production runs were conducted on a system shown schematically in Figure 1. The carbon ribbon substrate was payed out from the 7.6 cm (3 inch) OD by 17.8 cm (7 inch) long cardboard substrate holding spool, using a simple friction brake to control tension. Initially the carbon ribbon substrate was wound directly on the spool. Without protection, the substrate often was scratched or twisted and broken. It was later found that if a 1-1/4 cm (1/2 inch) mylar ribbon was wrapped on the spool with the carbon ribbon, these breakage problems were eliminated. The carbon ribbon was passed over pulleys to guide it to the reactor stages, one pulley driving a tachometer which provided a power shutoff interlock when the ribbon stopped for any reason. The first stage served as a ribbon finishing reactor in which the ribbon was heated to a temperature well above SiC deposition temperature, without which the carbon ribbon was unstable during SiC deposition (i. e. , small circular spots of SiC would break out and separate after part of the deposition was completed). The next step in the sequence was substrate cleaning, when used. The first cleaning procedure consisted of passing the ribbon through rubber slits through which a high air flow was passed. Later, another step was added consisting of polishing both sides by rubbing with rubber wheels as shown schematically in Figure 2. The reactor is shown in operation in Figure 3 where the key parts are shown.

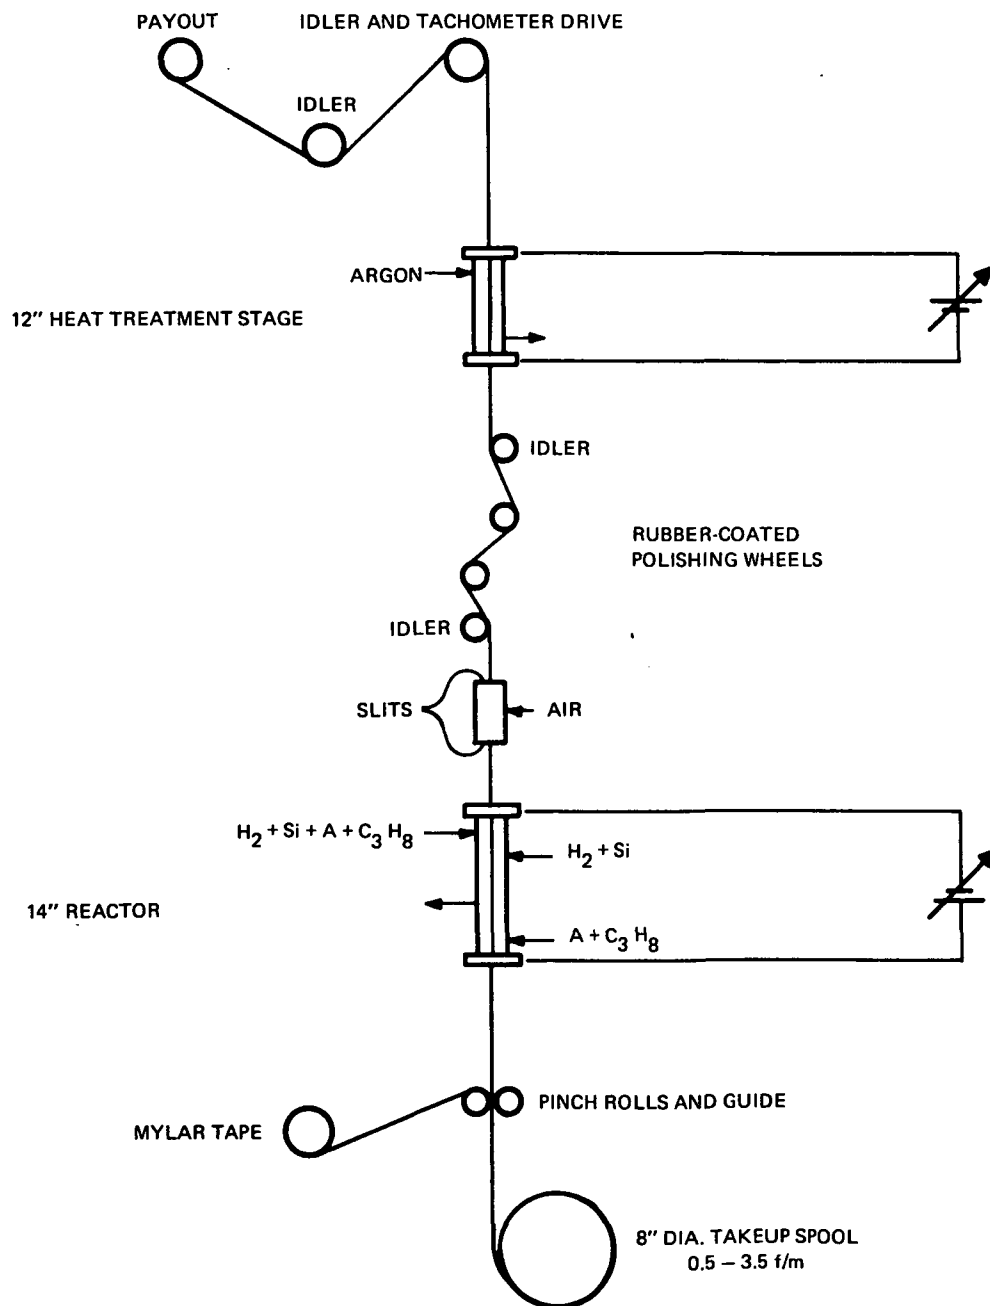
86-1525

Figure 2 SCHEMATIC DIAGRAM OF THE SiC RIBBON DEPOSITION REACTOR
AS OF AUGUST 31, 1974

The two power suppliers shown in the schematic of Figure 2 were both three phase full wave rectified 60 cycle power supplies rated at 3 amperes, and controlled with 3 phase ganged autotransformers. The supply for the cleaning stage was rated for 750 volts and the supply for the SiC deposition reactor for 4000 volts. These provide adequate voltage and current for this program.

The SiC deposition reactor included three zones, each supplied with a different mixture. The top zone, about 2.5 cm (1 inch) long, was supplied with a mixture of hydrogen, silane, argon, and propane. An additional mixture of hydrogen and silane, each of much higher flow rate than those in the first section, was added at the beginning of the second section. The second section

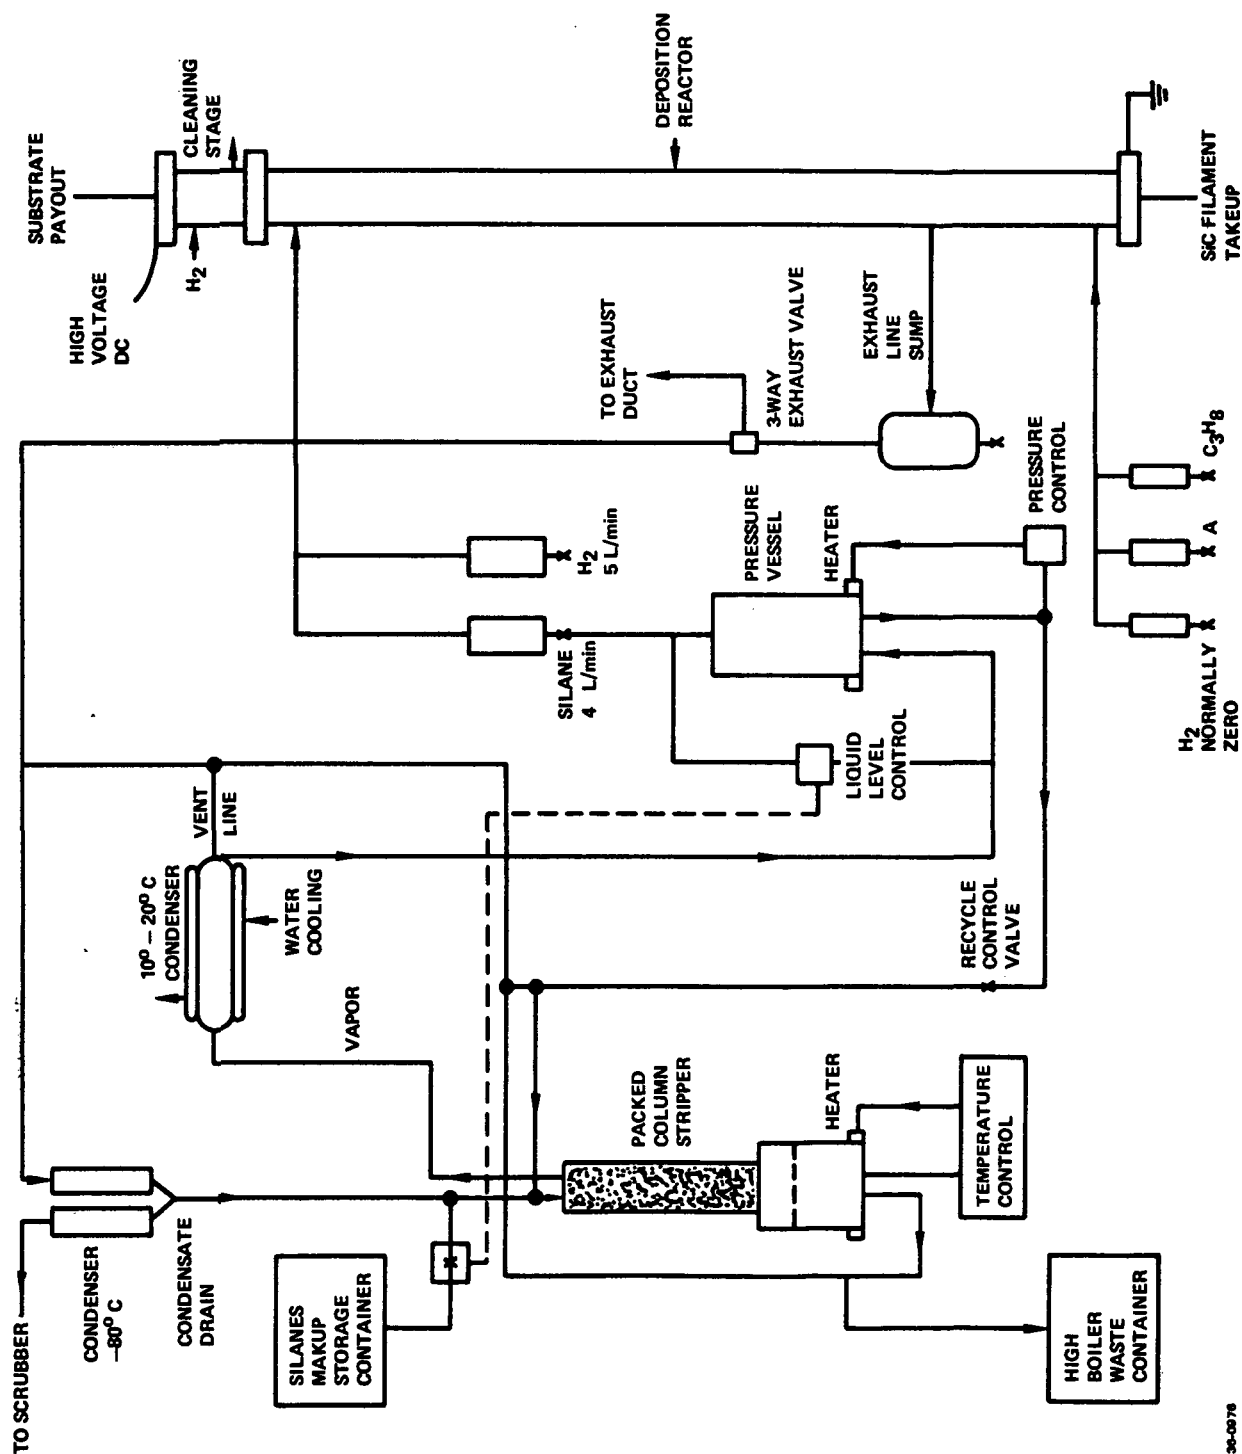
36-0876

Figure 4 SIC FILAMENT PRODUCTION PROCESS SCHEMATIC

The silane supply and recovery system used for the SiC deposition studies is shown schematically in Figure 4, developed during an earlier program⁽⁵⁾. The silanes mixture, consisting of a blend of dimethyldichlorosilane (Me_2SiCl_2) and methyldichlorosilane (MeHSiCl_2), together with the volatile

decomposition products of the reaction (primarily trichlorosilane, HSiCl_3 , and silicon tetrachloride, SiCl_4) are supplied as vapor from the reboiler vessel. This vapor, with a dew point of about 65°C (150°F), was metered through heated flowmeters, mixed with hydrogen and other gases when used, and sent to the reactor. The unused silanes and reaction products were condensed in condensers cooled with dry ice and freon and packed with Raschig rings or small glass beads. The hydrogen and HCl by-product were exhausted to atmosphere. The condensate was distilled in a packed distillation column to reject the high boiling products synthesized in the reactor (primarily disilanes -Si-Si- and disilmethylenes $\text{-Si-CH}_2\text{-Si-}$). The volatile components, with boiling points below about 100°C (212°F), were returned to the reboiler vessel.

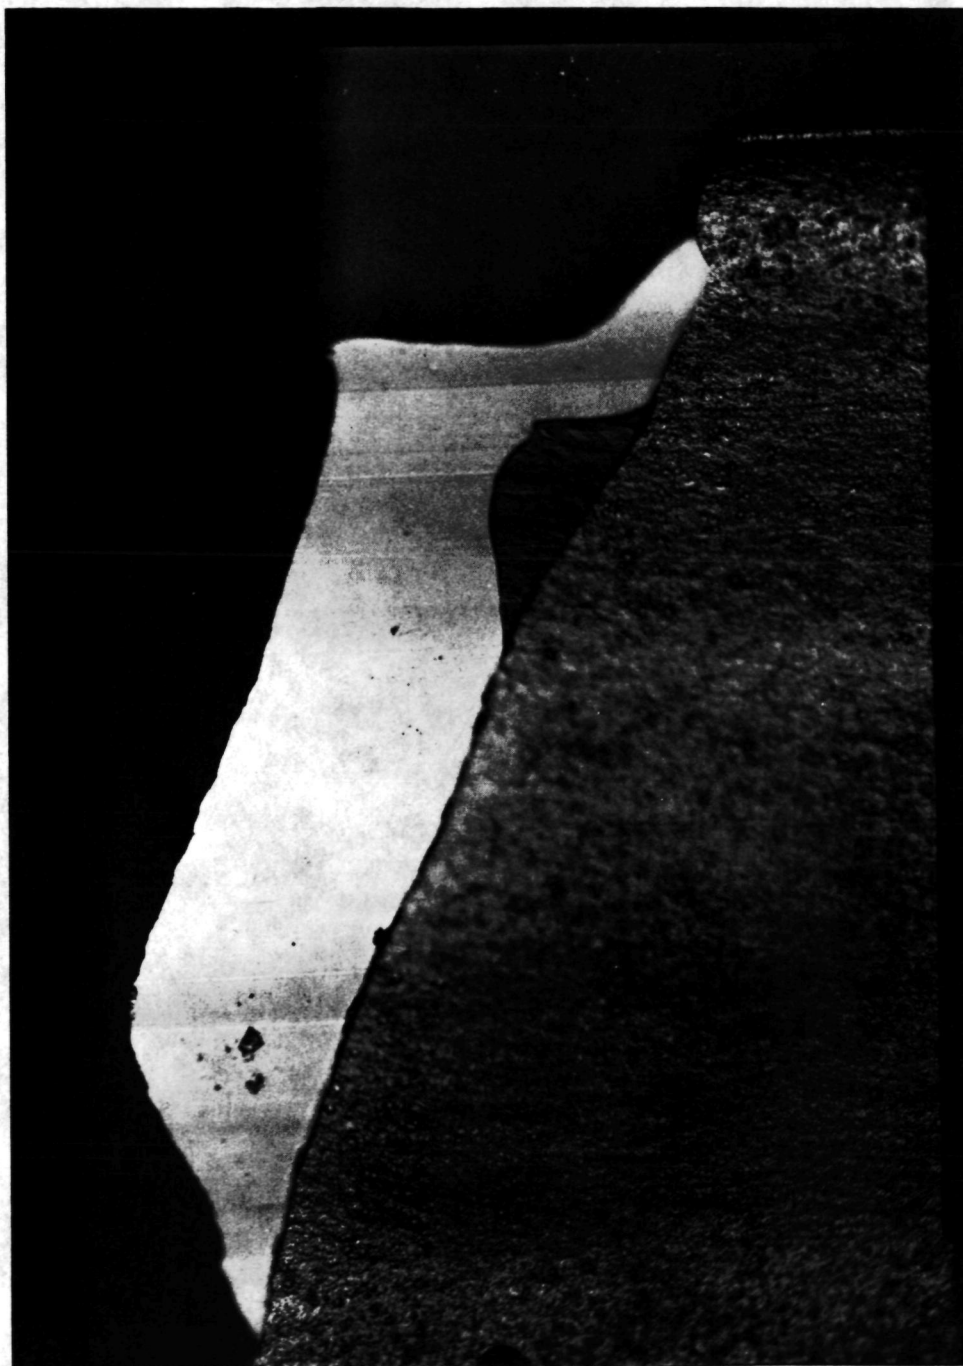
Figure 7 SIDE VIEW OF THE BROKEN END OF A SiC RIBBON

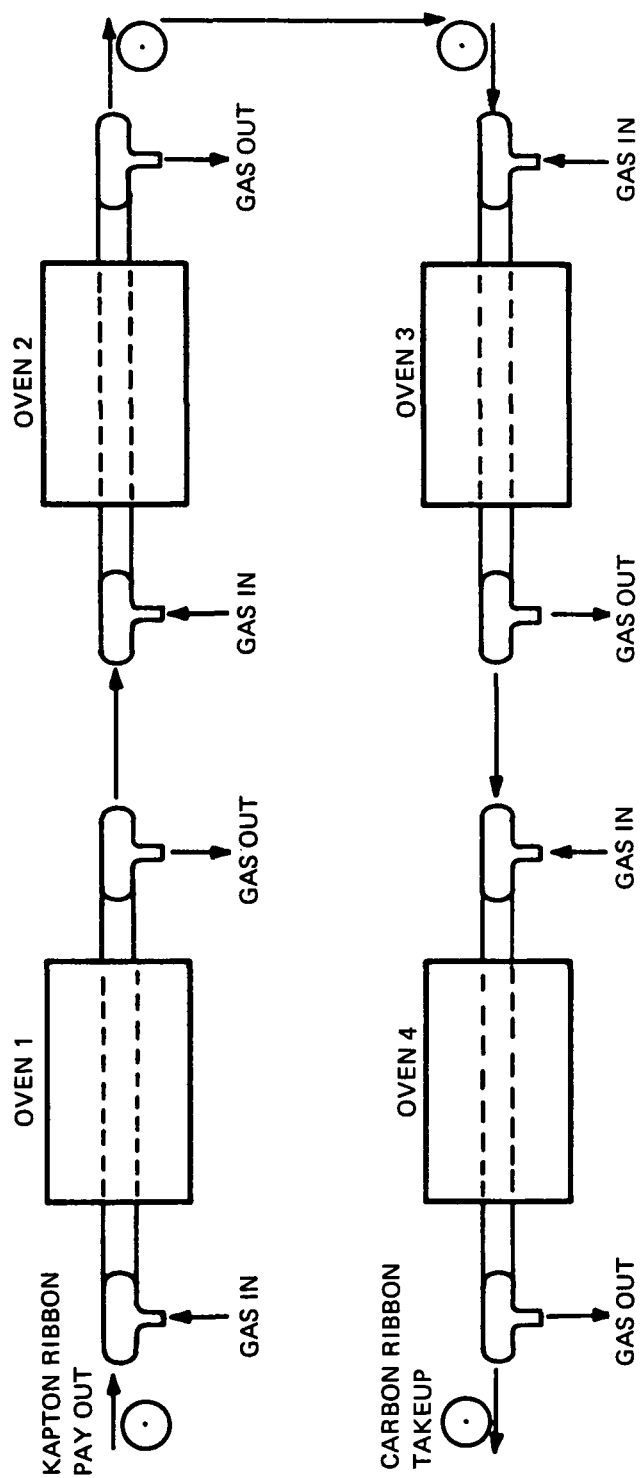
86-1526

Figure 8 TUBE FURNACE ASSEMBLY

Carbonization of Kapton was conducted using a four oven arrangement, as shown schematically in Figure 8 below. Partial carbonization of polyimide ribbon was achieved at rates of 0.15 to 0.45 meters/min (1/2 to 1-1/2 ft/min). Both air and nitrogen gases were used in co-flow. No excessive tar build-up occurred which could drop off onto the ribbon. Transverse curling was reduced by using the quartz wheel and roller assembly, shown in Figure 9, instead of the ladder arrangement. There were some ribbon tension problems in the system from the rollers; however, the overall tension was lower as compared with the previous quartz ladder arrangement.

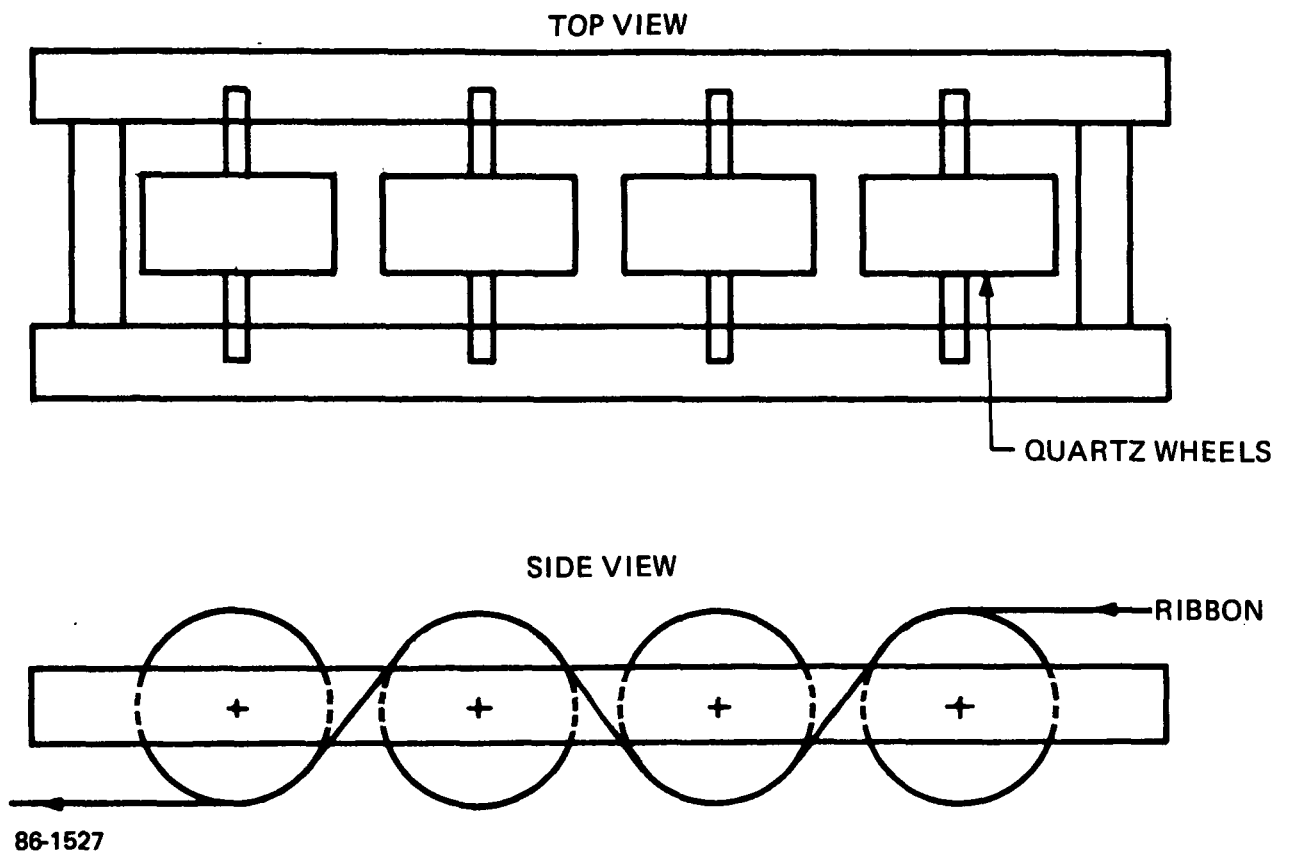
Figure 9 TOP VIEW AND SIDE VIEW OF THE CARBON RIBBON ROLLER ASSEMBLY

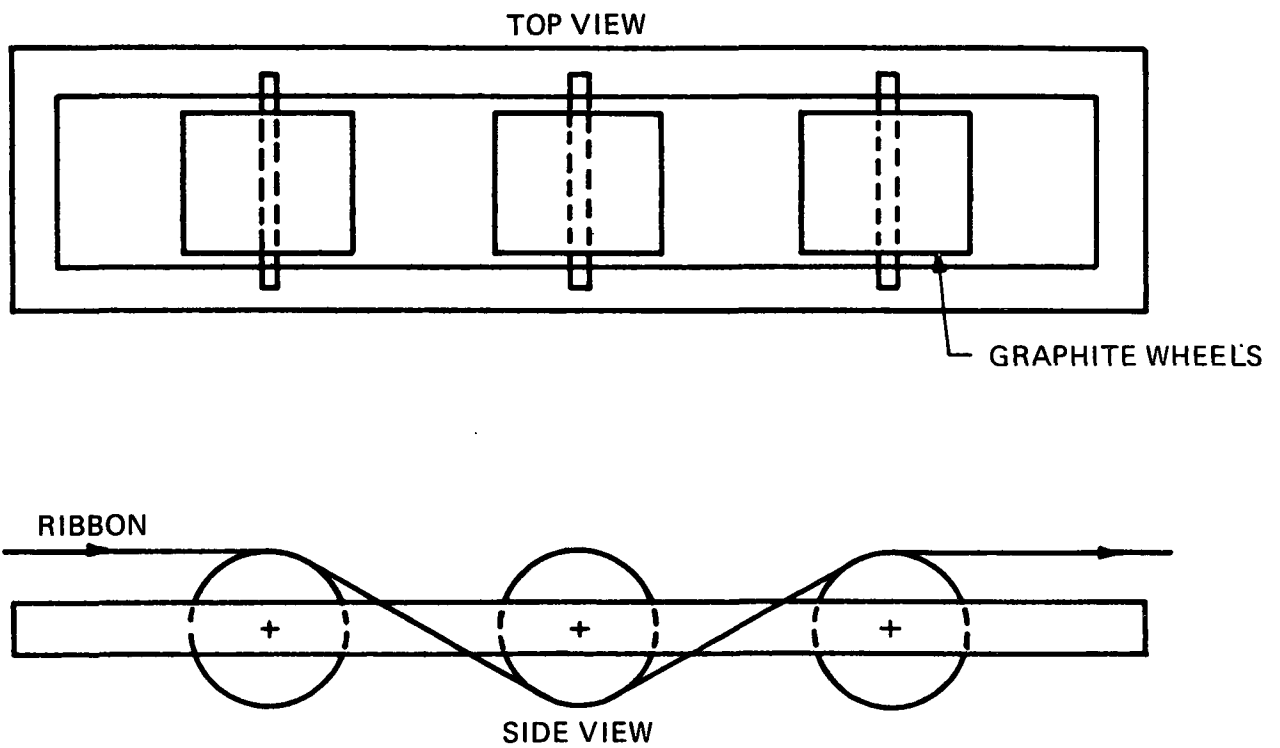
86-1528

Figure 10 TOP VIEW AND SIDE VIEW OF CARBON RIBBON ROLLER ASSEMBLY

During January 1975, several stages of improvements were evolved on the roller-wheel guide concept, and the wheel guide system as developed then is shown in Figure 10. The roller guides, as stated above, were installed to maintain flatness in the ribbon by preventing curling of the polyimide film during the dimensional change which occurs at the 500-1100°C (930-2010°F) treatment temperature and were changed to graphite to prevent sticking. The first successful configuration used was a furnace with two heating zones, using a 3-wheel guide in the second zone. The first zone was operated at 500°C (930°F) and the second at 1100°C (2010°F) and the N₂ flow was in the same direction as (concurrent with) the ribbon motion. The first run was about 45 meters (150 ft.) long and was limited only by the initial length of polyimide film on the test roll. One very interesting observation about this configuration was the absence of exhaust smoke as was observed from the first half of the two-stage furnace which was used previously.

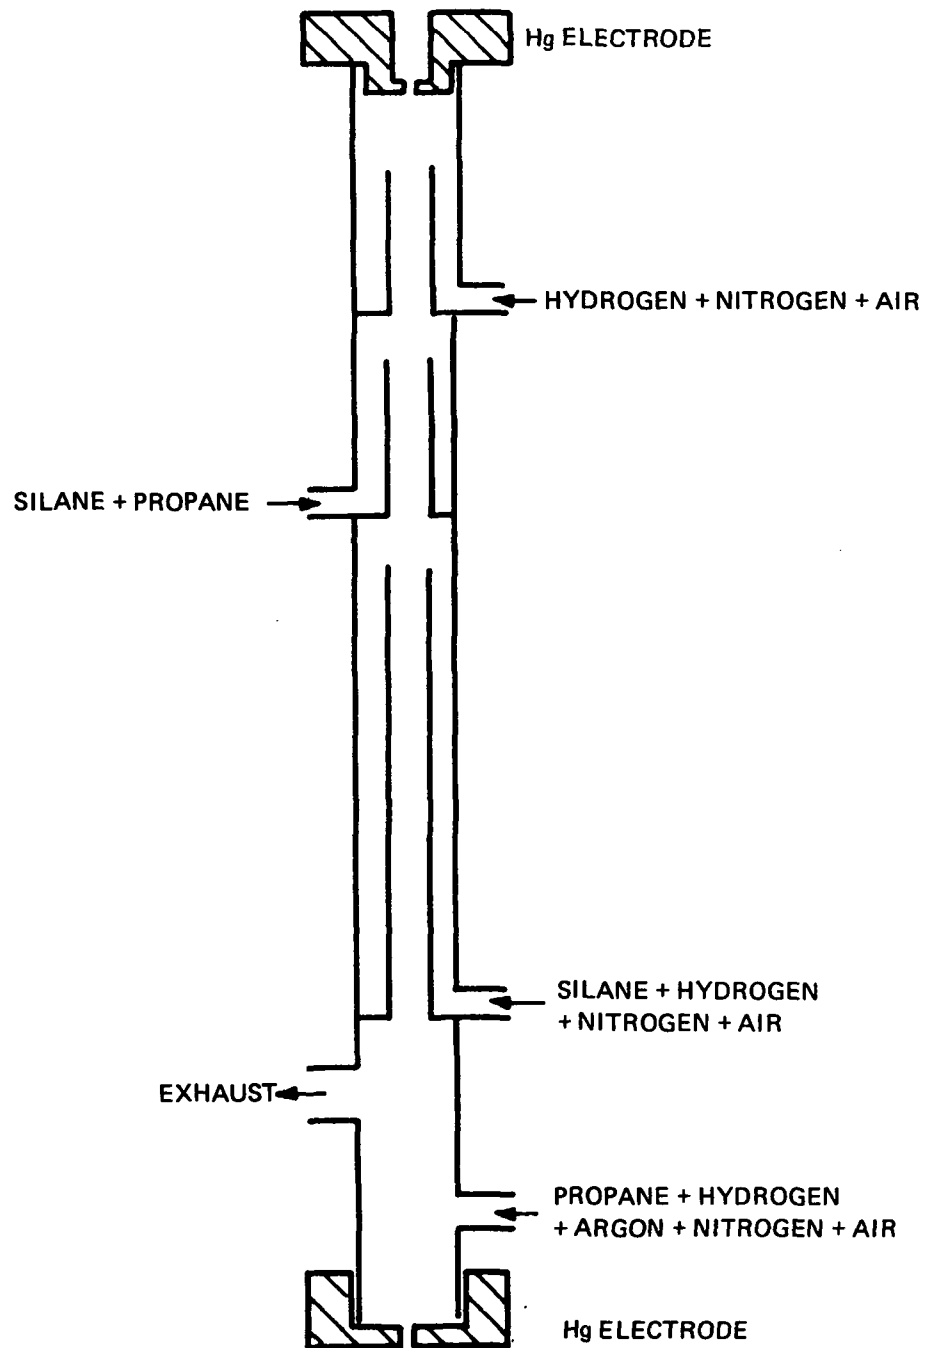
86-1529

Figure 11 MODIFIED SILICON CARBIDE REACTOR
